CONNECTICUT RIVER BASIN
MIDDLETOWN, CONNECTICUT
DOOLEY POND DAM
CT 00142

PHASE I INSPECTION REPORT
NATIONAL DAM INSPECTION PROGRAM

AUGUST 1980

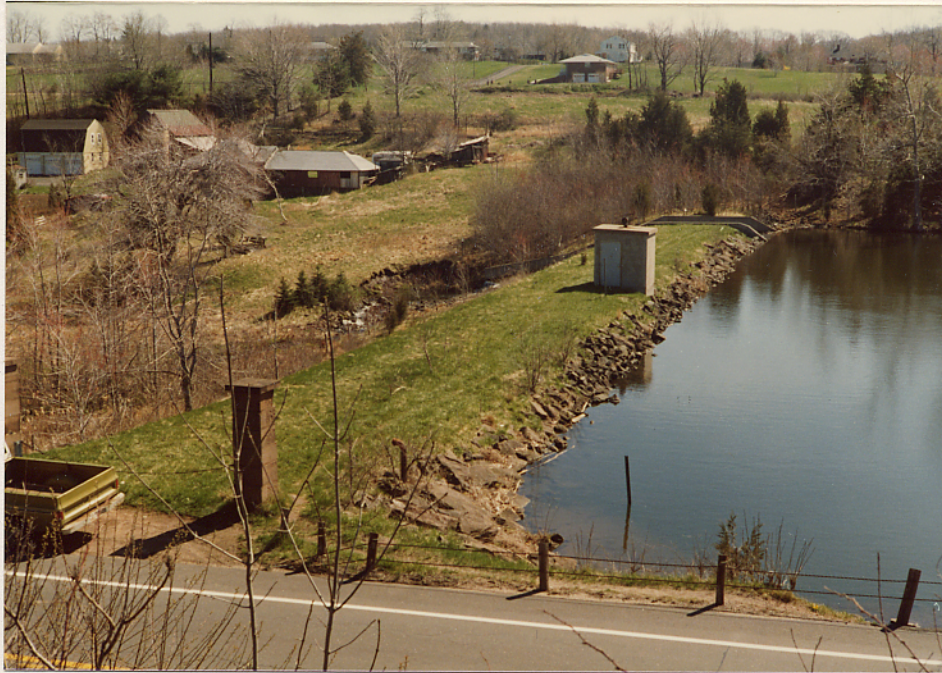
Upstream Slope - Displacement of riprap has occurred at many areas along the slope, leaving exposed earth zones, which are slightly eroded. Some brush was noted on the slope (Photos 1 & 2).

Photo 1 - Upstream slope and top of dam (4/21/80).

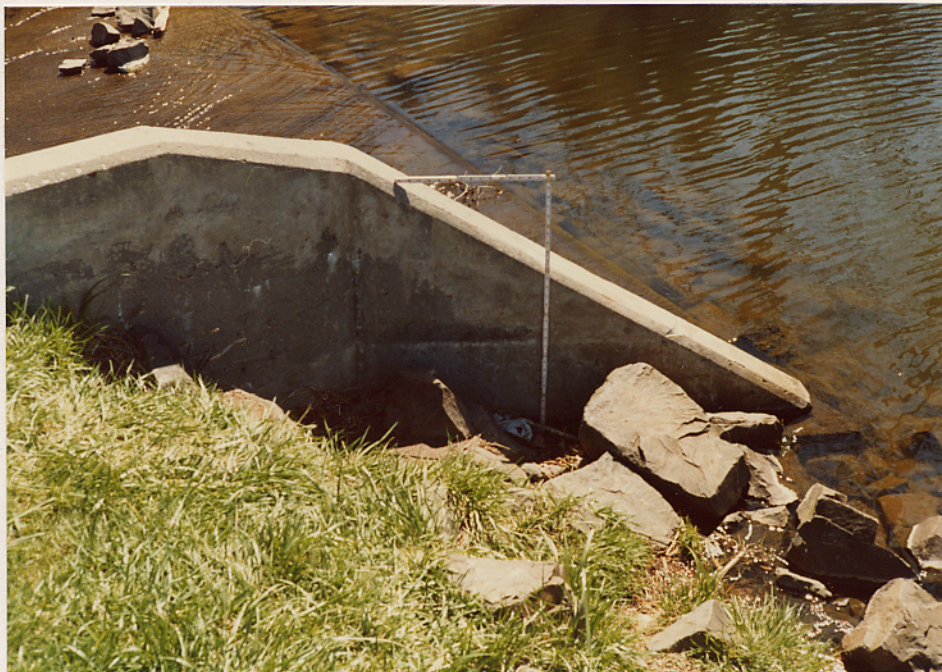
Photo 2 - Displaced riprap and erosion of upstream slope (4/21/80).

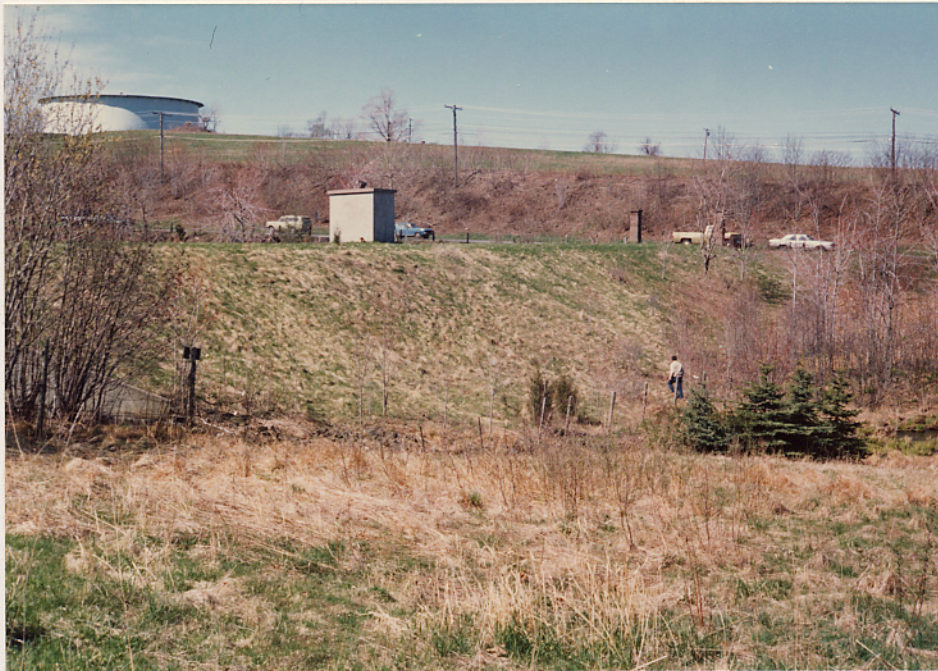
Downstream Slope - The downstream slope is covered by grass except for a minor amount of brush and small trees. In general, the slope is uniform; however, moist soils and a depression were observed in an area at the right side of the embankment. The ground at the toe of the dam is wet and soggy, especially near the left abutment of the embankment (Photo 3).

Photo 3 - Downstream slope and toe of dam (4/21/80).

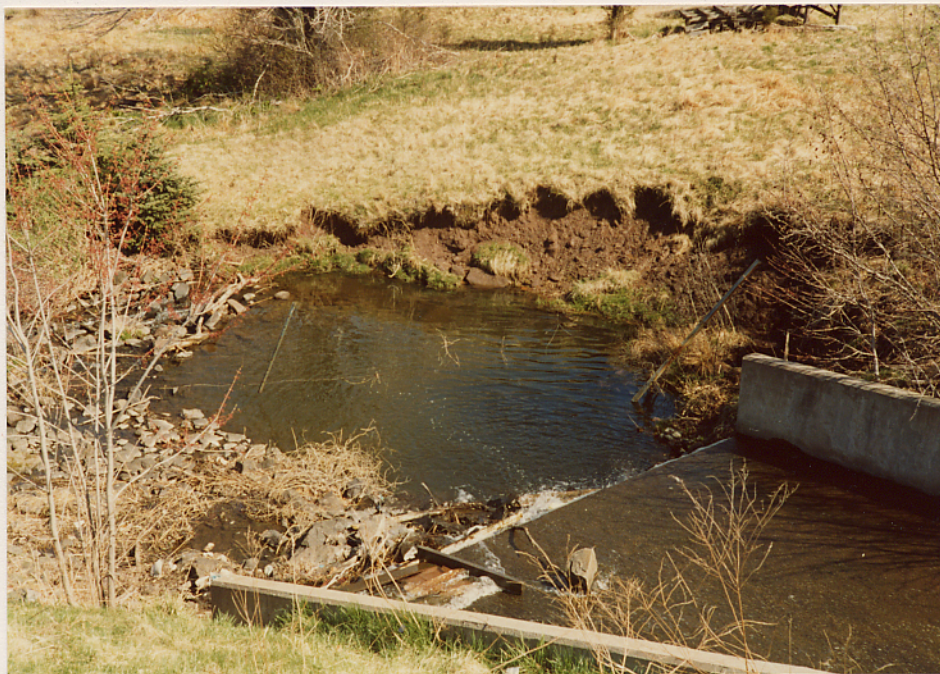
Spillway - The concrete of the spillway weir and chute is in good condition. There are a number of vertical cracks with openings of up to $\frac{1}{4}$ inch on both spillway training walls. The cracks usually are located at the wall corners and construction joints. Rocks and logs were observed on the spillway weir and at the end of the chute floor (Photos 4 & 5). Both the bottom and right bank of the spillway discharge channel are severely eroded adjacent to the concrete spillway chute. Riprap, shown on design drawings, is missing, having apparently been eroded away. The deepest erosion of the channel bottom, approximately 3.5 to 4 feet deep, is at a distance of 10 feet from the end of the chute (Photo 5). Erosion of the right channel bank extends into the bank approximately 15 to 20 feet from the channel water line and has a maximum depth of 8 to 10 feet (Photo 4). The steeply eroded bank is saturated and many seeps, with a total flow of 6 to 8 gallons per minute (gpm), are emanating from it. This seepage flow is probably mainly from the adjacent hillside and only partially from the embankment. An accumulation of rocks and logs mark the downstream end of the channel bottom erosion and causes ponding of water at the bottom of the spillway chute (Photos 4 & 5).

Photo 4 - Eroded area of spillway discharge channel (4/21/80).

5. Cracks in the concrete of the spillway training walls should be sealed.
6. The scouring and erosion of the spillway discharge channel should be repaired, including clearing of obstacles and placement of riprap or other suitable measures undertaken to prevent further deterioration of this area.

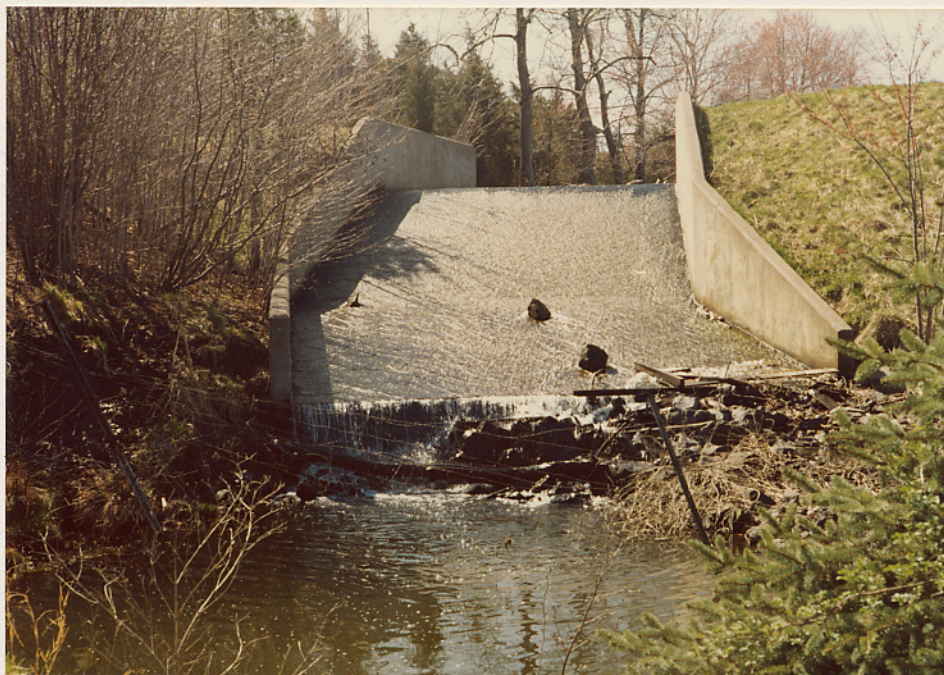
Photo 5 - Concrete spillway chute. Note drop off at end of chute and debris in channel (4/21/80).

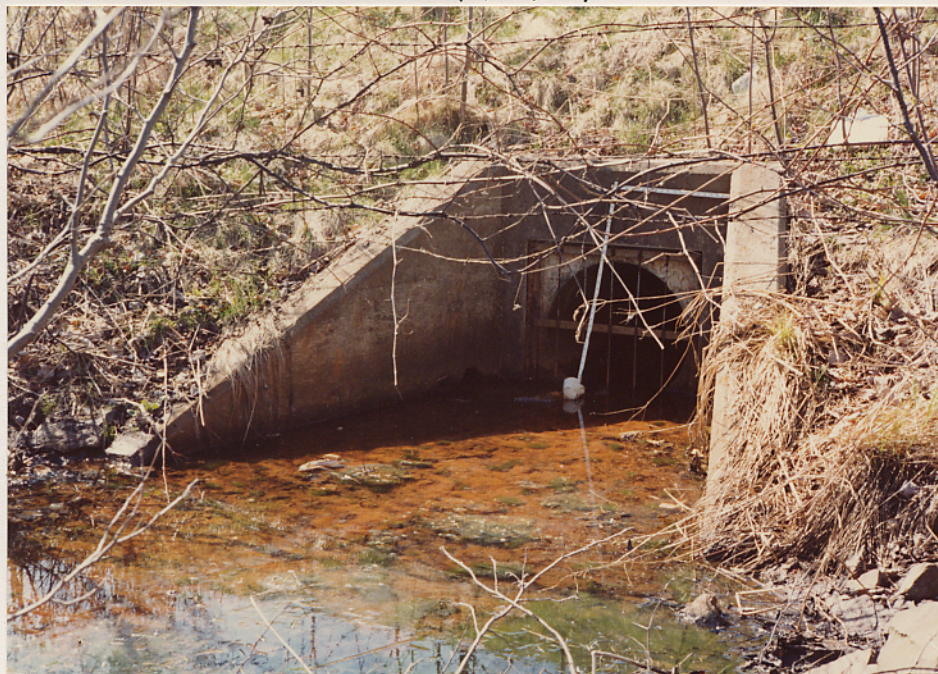
c. Appurtenant Structures - The concrete of the 24 inch low-level outlet headwall is in good condition. Both 6 inch concrete drain pipe outlets, located on the right and left wing walls, were flowing with a total rate of 3 to 4 gpm, with most of the flow from the right drain pipe. The floor of the low-level outlet is covered by 3 inch thick brown silt deposit and small stones (Photo 6). Stagnant, or nearly stagnant, water was observed in the outlet discharge channel. The cause of this condition may be the very gentle grade of the channel bottom.

Photo 6 - Low-Level outlet headwall. Note stagnant water in outlet and partially submerged drain pipe to left of 24" outlet pipe (4/21/80).

7. Rates of seepage from the two 6 inch drain pipes at the low-level outlet headwall should be monitored periodically to evaluate the condition of the embankment and the effectiveness of the toe drain system.
